#### Official Information Act (1982) Request

The three buildings that underwent DSA following unsatisfactory ISA results, and which we are now releasing as attached documents, are Franklin Memorial Hospital, Pukekohe Plant Room and Esme Green.

Beca has been engaged to complete intrusive investigations at the Franklin Memorial Hospital site at Waiuku, Auckland. The investigation findings will inform the next steps of the seismic assessment and strengthening process. This letter summarises our findings and provides options and recommendations for Counties Manukau Health (CMH) to consider.

Beca has been engaged to complete intrusive investigations at Building 38 located on the Middlemore Hospital campus, in Otahuhu, Auckland. The investigation findings will inform the next steps of the seismic assessment and strengthening process. This letter is a factual summary of our findings and provides options and recommendations for Counties Manukau Health (CMH) to consider.

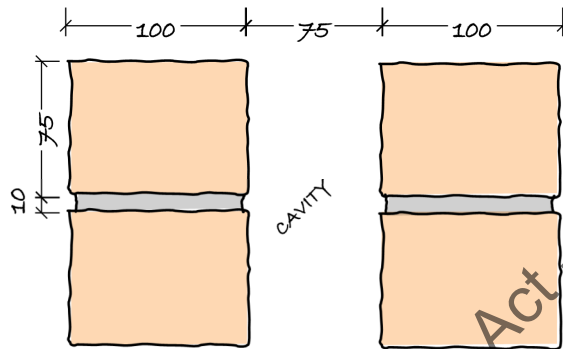
- Bricks – the bricks were measured as 210 mm long, 76 mm deep, and 100 mm wide. The bricks were noted as being ‘hard’ as they were unable to be scratched with a coin. The hardness of the brick, relative to the mortar is important as it can lead to a brittle failure mechanism.
- Mortar – the mortar joints were approximately 10 mm thick. The mortar did not scratch away easily when using a key, suggesting it is also ‘hard’.

Figure 1: Typical brick dimensions and cavity layout

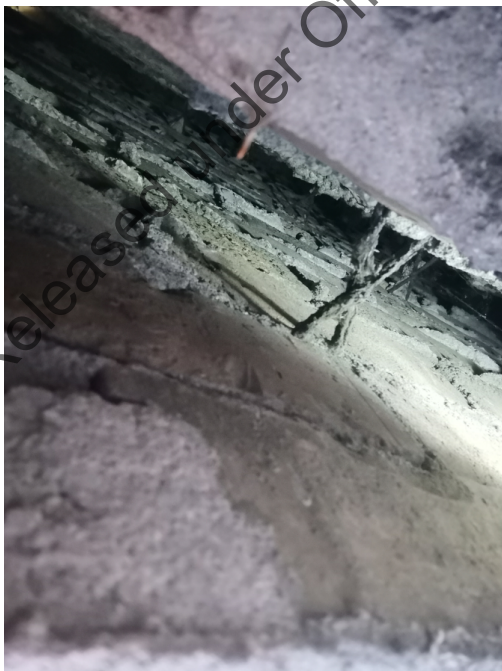
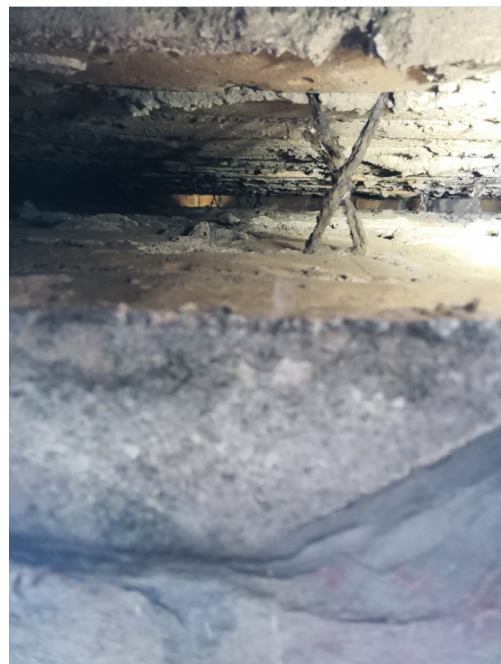
- Exterior Walls - the exterior walls are cavity brick construction. This consists of a single exterior veneer layer of bricks approx. 100 mm wide, a cavity 75 mm wide, then an internal brick layer. Beneath the floor level, the brick becomes solid to form a perimeter foundation wall. Cavity ties were observed to be at approximately 900 mm centres horizontally, and 1000 mm centres vertically. The ties appear as approximately an 8 gauge wire.

Figure 2: Evidence of cavity ties in external walls

The building has extensive use of unreinforced masonry (URM) load bearing internal single skin partitions and external cavity walls. Cavity ties were observed in the cavity walls, however the spacing and condition of these is inadequate to provide robust composite action between the two brick wythes. This suggests the external walls will act primarily as single skin walls. Single skin walls are particularly vulnerable to seismic shaking.

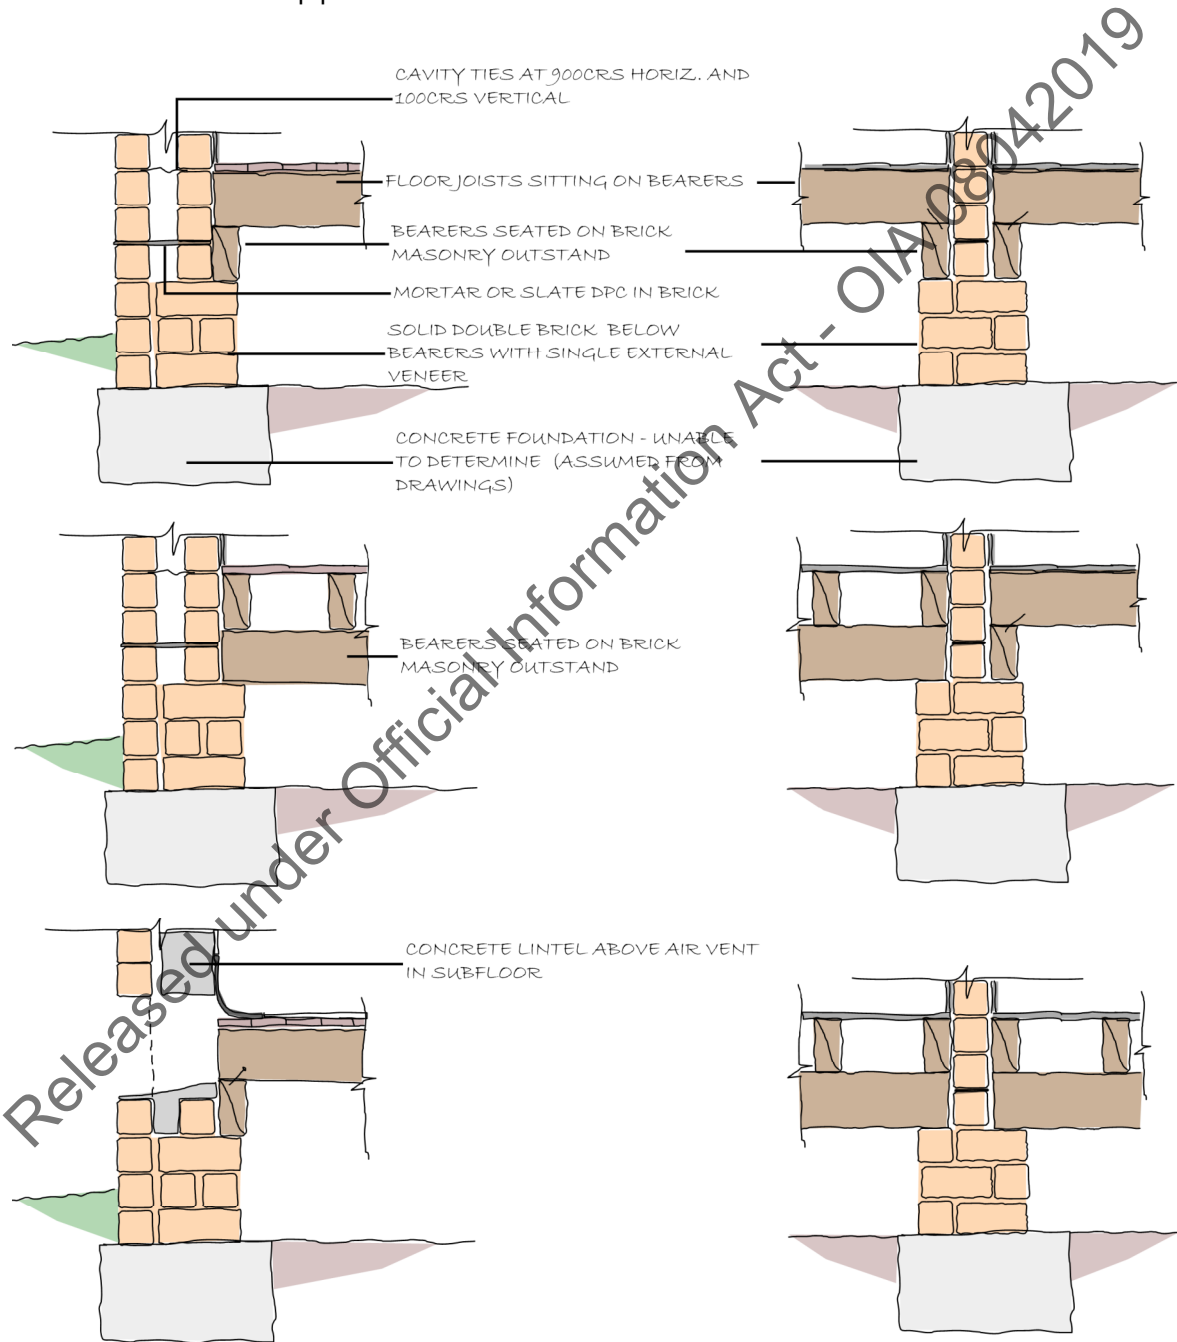
- Interior Walls – the interior walls are generally single brick with plaster linings directly fixed to the brick surface. In the northern area of the building where renovation works have been undertaken, timber stud walls have been constructed adjacent to the brick partition walls, but are unlikely to have a physical connection between the studs and the brick.  
There is some evidence of internal double brick cavity walls. The construction of these, including cavity width is expected to be similar to the exterior walls.  
The connection to the top plate was unable to be observed.

**Figure 3: Typical construction details observed (top) typical cross section with joists transverse to exterior walls, (middle) joists parallel to walls (bottom) section through ventilation grate**

The walls are either cantilever or span vertically between the ceiling and the foundation, likely the former. This means the single layers of brick are particularly vulnerable to local failure, falling from height to form a potential life safety risk. The fact the walls are load bearing means there is a risk of local or global collapse of the roof structure due to failure of the walls, leading to a potential life safety risk for occupants.

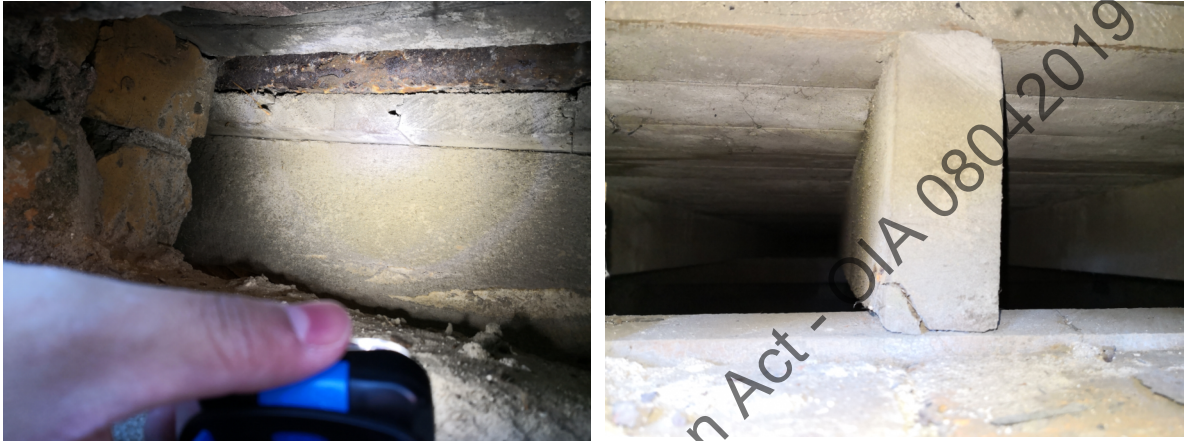
- Subfloor framing – the subfloor structure generally consists of 140 x 45 timber floor joists at 400 centres supporting 25 thick timber tongue-in-groove flooring. The joists are supported by bearers which span between small brick columns or between the brick foundation walls that continue through from above. There does not appear to be any direct connection (other than gravity support) between the floor and the brick walls, with the walls passing through the floor. No blocking between the timber joists was observed.

**Figure 4: Subfloor framing showing timber floor joists connected to timber bearers**

The floor structure is discontinuous through the internal walls, and the floor joists are not blocked at their ends. The lack of a connection to the floor means the walls are required to span down to the foundation level. This also means there is little likelihood of a distribution diaphragm to create a load path to stiffer foundation elements.

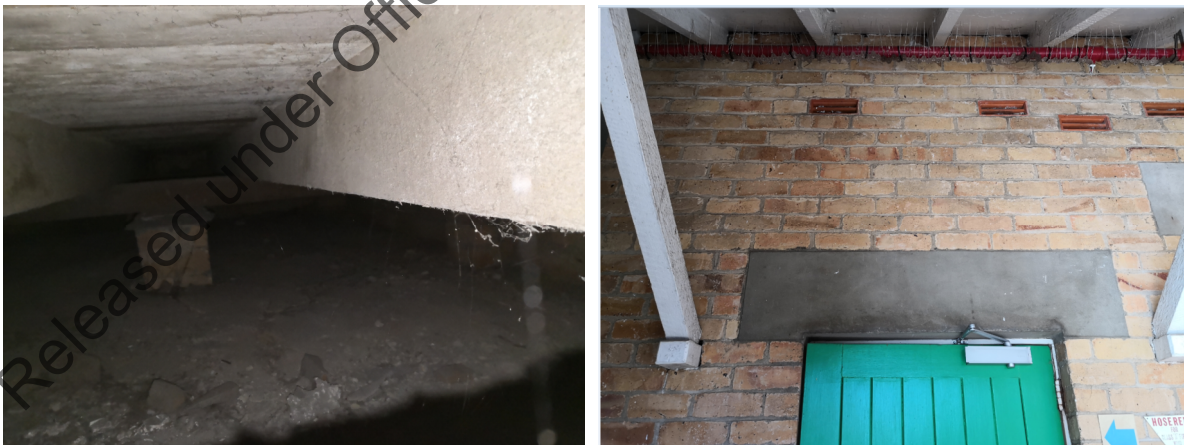
- Foundations – the timber bearers sit on brick jack piles. The connection of these was not evident beyond simple bearing on the top surface of the column.
- Lintels – the lintels above windows and doorways are concrete. It is unknown if these are reinforced.

**Figure 5: (left) Timber bearer sitting on solid brick column (right) concrete lintel above doorway**

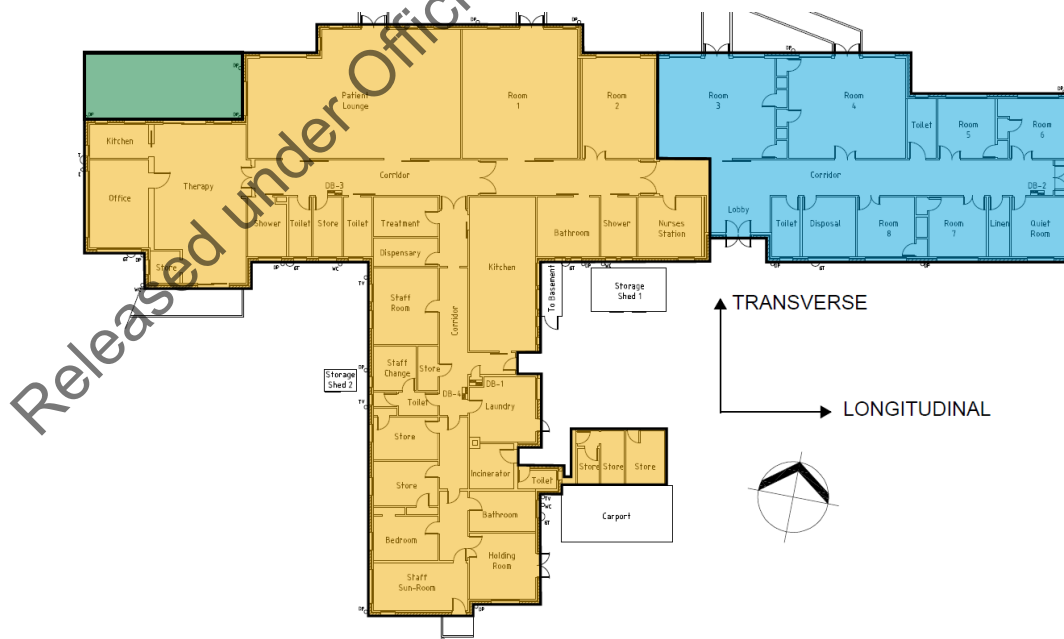
Note the area shown in yellow below is the original structure that has a number of potential critical structural weaknesses. The areas in blue and green are of modern construction (1980s) and are expected to perform adequately in an earthquake. Strengthening works are thus concentrated to the original area of the building.

**Figure 6: Plan of Franklin Memorial Hospital showing the various construction ages. The yellow section is the original building footprint**

- The removal of the brick chimneys
- New structural timber stud walls and lining to all external and internal URM wall. The studs will be fixed through to the brick walls to improve their seismic performance. The new timber studs will also have a top plate securing the top of the brick walls. This top plate will sit under the asbestos material, to avoid disturbing it, and span between adjacent perpendicular walls. Alternatively the internal single skin walls would be removed completed and replaced with timber framing.

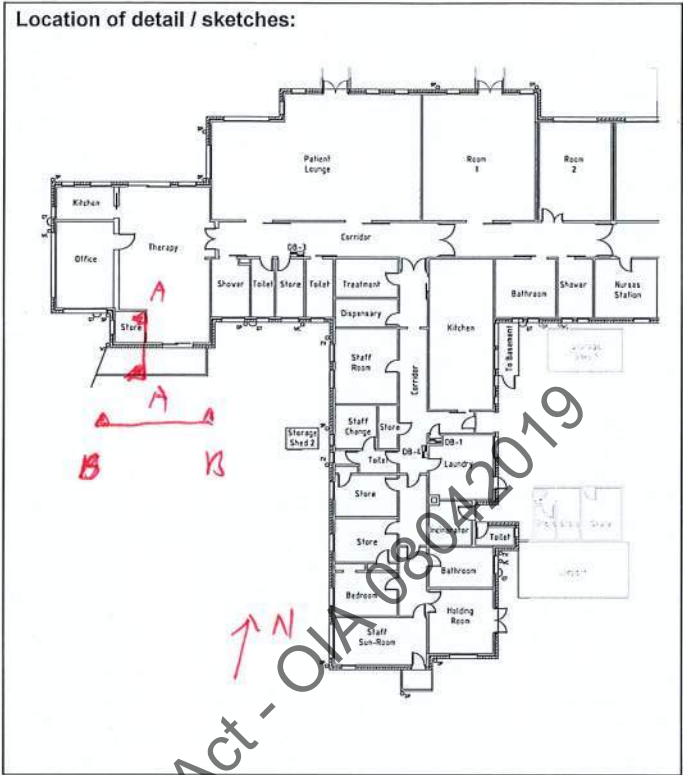
Description/Comments: Exterior wall on southern side of building. removed the ventilation net to observe cavity construction. Bricks with minor cracks.

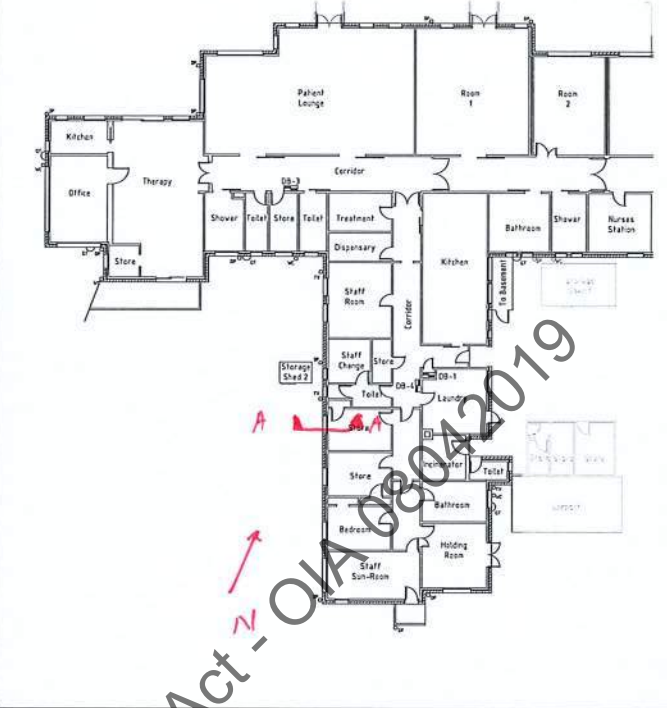
Wall in good condition with minor cracks.  
- Brick tie spacing similar to wall 1.

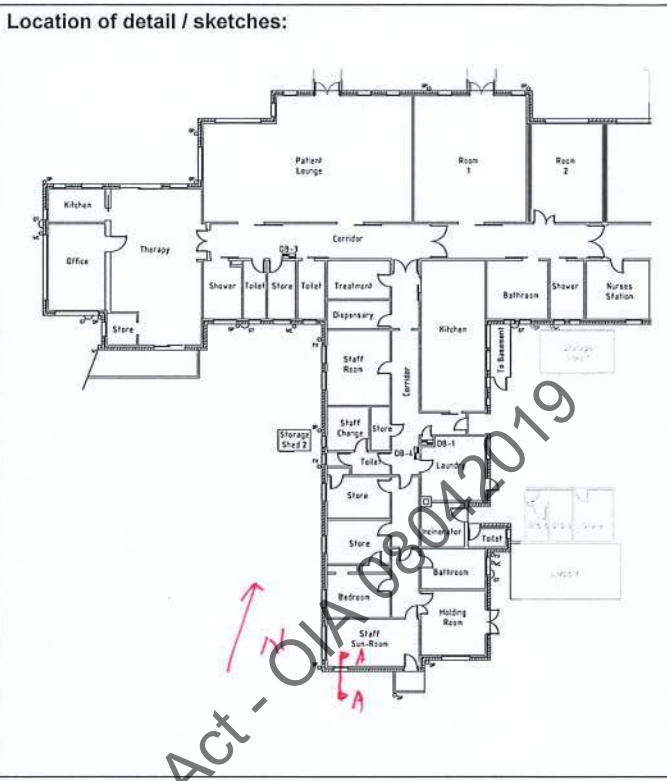
Section No.: *Exterior wall 3*

Description/Comments: *- New Mortar repair in late stage*  
*- wall recess 75mm from exterior*  
*- No brick to found on this wall*  
*- Minor cracks on bricks*

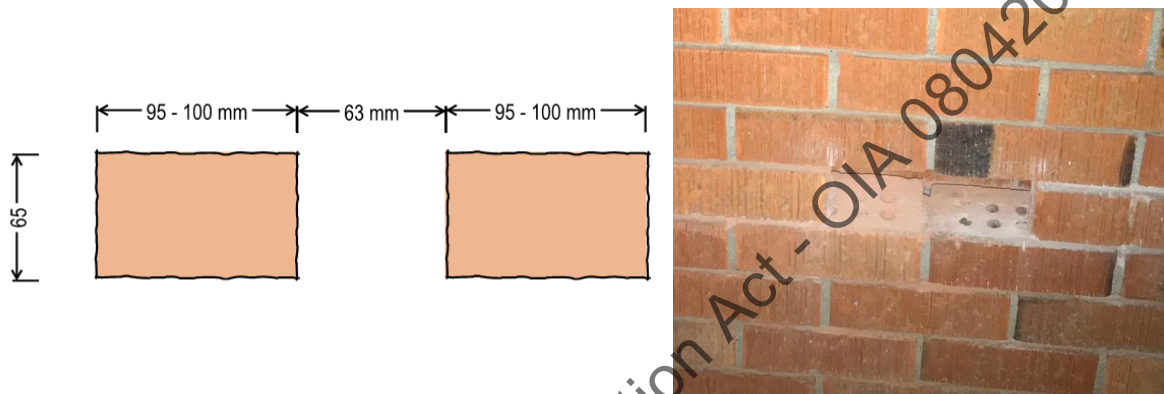
- **Bricks** – the bricks were measured as 210 mm long, 65 mm deep, and 100 mm wide. The bricks were identified as 'hard' being unable to be scratched with a coin. The hardness of the brick, relative to the mortar is important as it can lead to a brittle failure mechanism. The bricks have numerous holes through them to allow grout to flow through and provide a better bond, however is unlikely to improve out-of-plane performance of the block walls.

Figure 2.1: Typical brick dimensions (left) and type with numerous penetrations through the brick

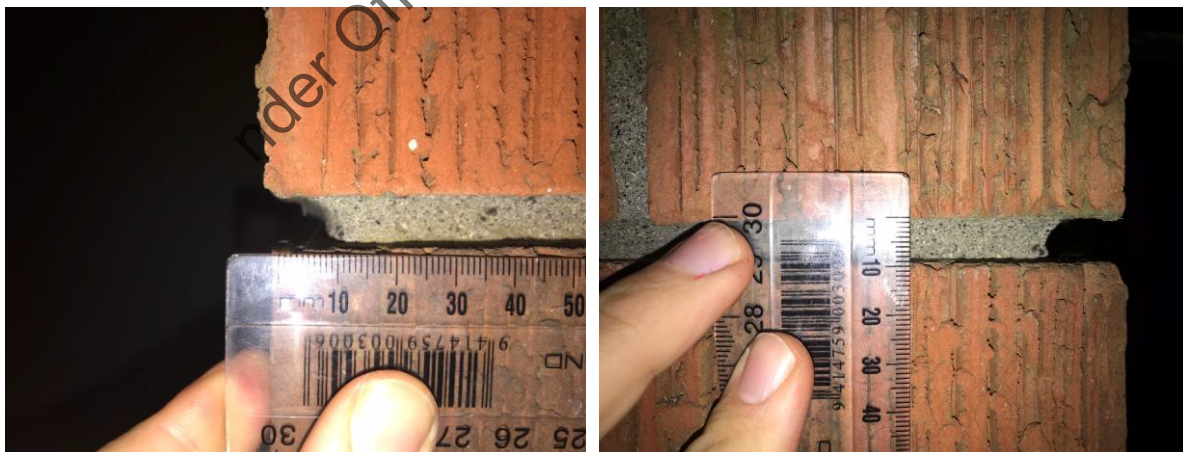
- **Mortar** – the mortar joints were approximately 10 mm thick. The mortar did not scratch away easily when using a key, suggesting it is also 'hard'. It was observed to be recessed approximately 10 mm from the external edge of the brick.

Figure 2.2: Typical brick dimensions and cavity layout

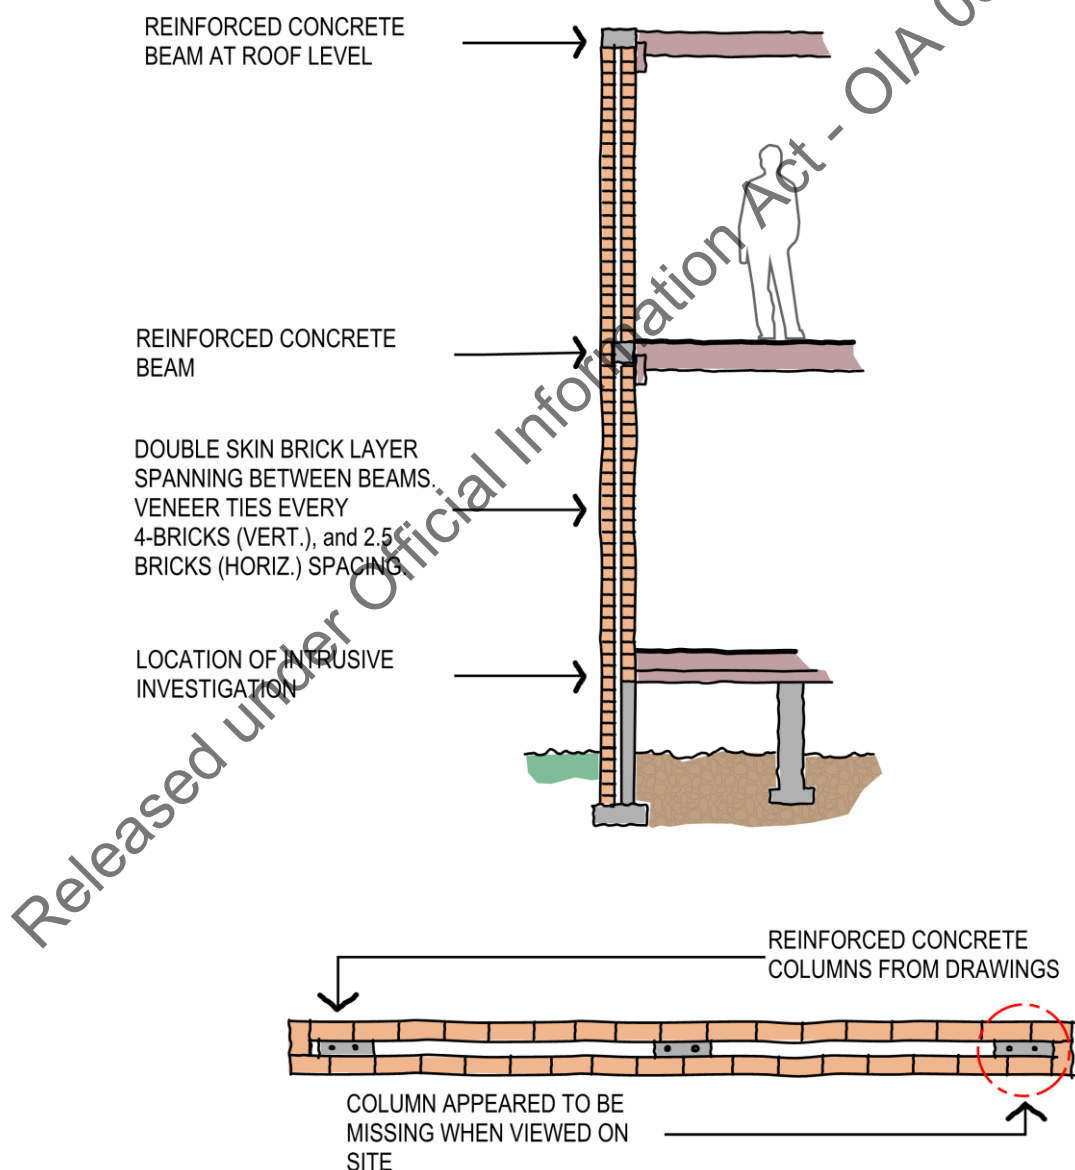
- **Exterior Walls** - the exterior walls are cavity brick construction. This consists of a single exterior veneer layer of bricks approx. 100 mm wide, a cavity 60-75 mm wide, then an internal 100 mm wide brick layer. The drawings note that the walls have three reinforced concrete columns present within the cavity space, with horizontal concrete beams at Level 1 and roof level. Formwork for constructing these columns was observed. The end column formwork did not appear to have a reinforced concrete column behind it, indicating the original contractor may not have constructed it per the drawings. An error like this from a contractor is uncommon but not unheard of. It does not affect the structural system for static vertical loads, however will have an affect on the lateral capacity.

Cavity ties were observed at 4-brick spacing vertically (approx. 300 mm centre) and 2 1/2 bricks horizontally (approx. 500 mm centres).

**Figure 2.3: Sketch of structural system as detailed on drawings and partially viewed during investigation. Section through (above) and plan view (below)**

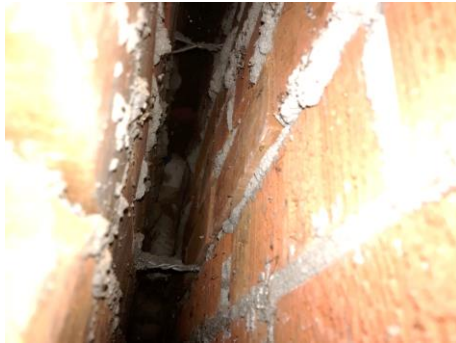
Evidence of packing formwork in distance

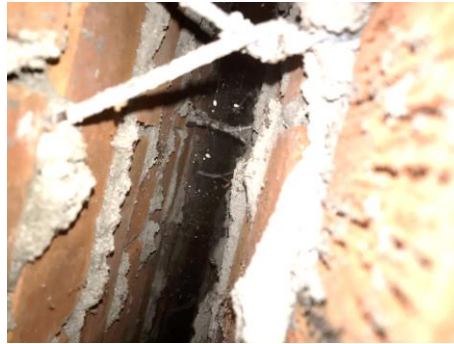
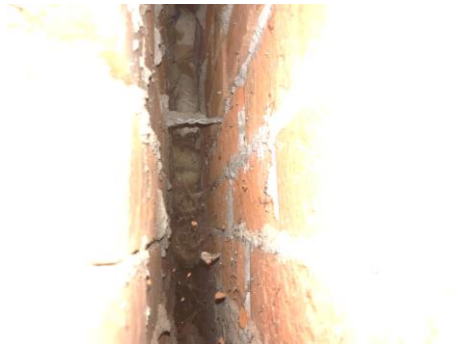
Packing in the distance used as form for internal column

Figure 2.4: Photos within cavity wall rotating 360 degrees as shown in central image

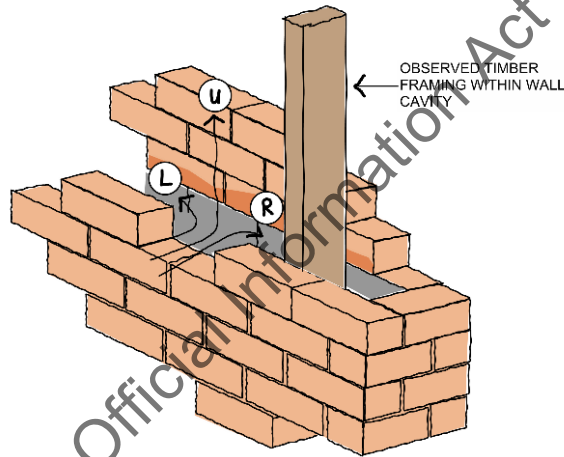
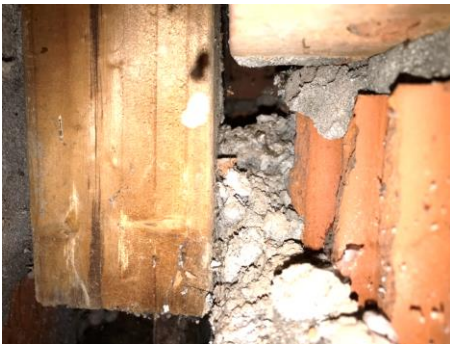
Timber form, however column not apparent behind

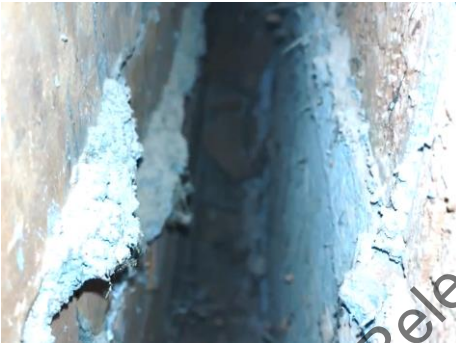
Note the concrete foundation wall on right side of photo

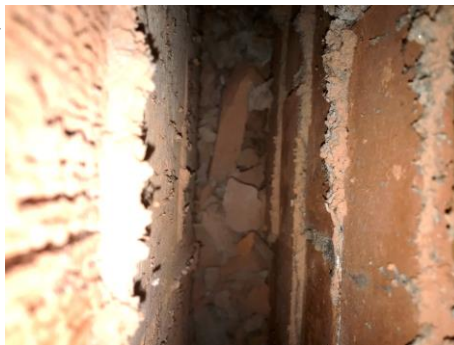
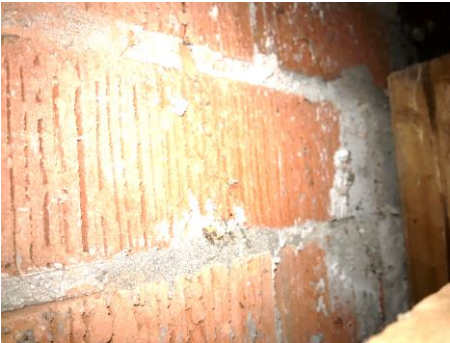
Concrete can be seen spilling out side of timber form

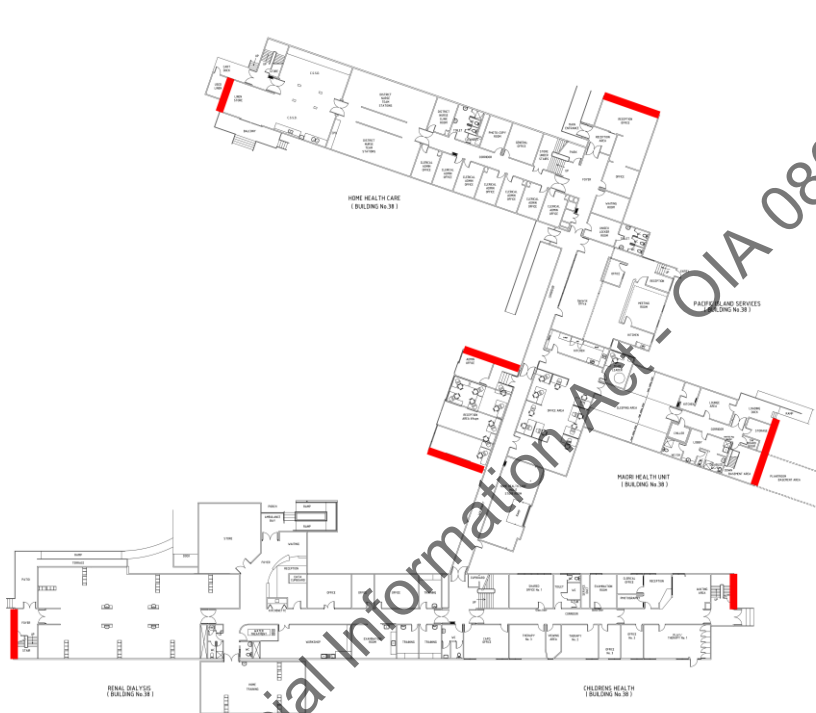
Figure 3.1: Extent of unreinforced masonry cavity walls in Building 38

The intrusive investigation has found that there is an internal concrete frame to the two-storey cavity brick walls. The frame consists of three columns, with horizontal bond beams at first floor and roof level. This means the walls are required to span vertically between the horizontal concrete beams, and these which in-turn span between the concrete columns.

The single storey sections of the walls are cavity construction and do not have the vertical concrete columns but do have a continuous reinforced concrete bond-beam at the top of the wall which is connected to the roof sarking. This means the wall spans between the foundation and roof level supports. It is assumed that the cavity ties are at a similar spacing to that observed in the two-storey walls.

Cavity ties were observed, and appeared to be in relatively good condition. Detailed calculations will be required to check the adequacy of the spacing. If the spacing is adequate and the cavity wall behaves as a single element, the score is likely to be  $>67\%NBS$  (IL3). If not, then the score is likely to be  $<34\%NBS$  (IL3).

We recommend that Beca undertakes the detailed calculations for the cavity ties between the walls. The checks will be a detailed seismic assessment of the walls. The results of these checks will either facilitate an update to the original ISA report, noting the improved performance; or will require the development of some strengthening solutions (like those for Pukekohe Hospital Plant room and Franklin Memorial Hospital).

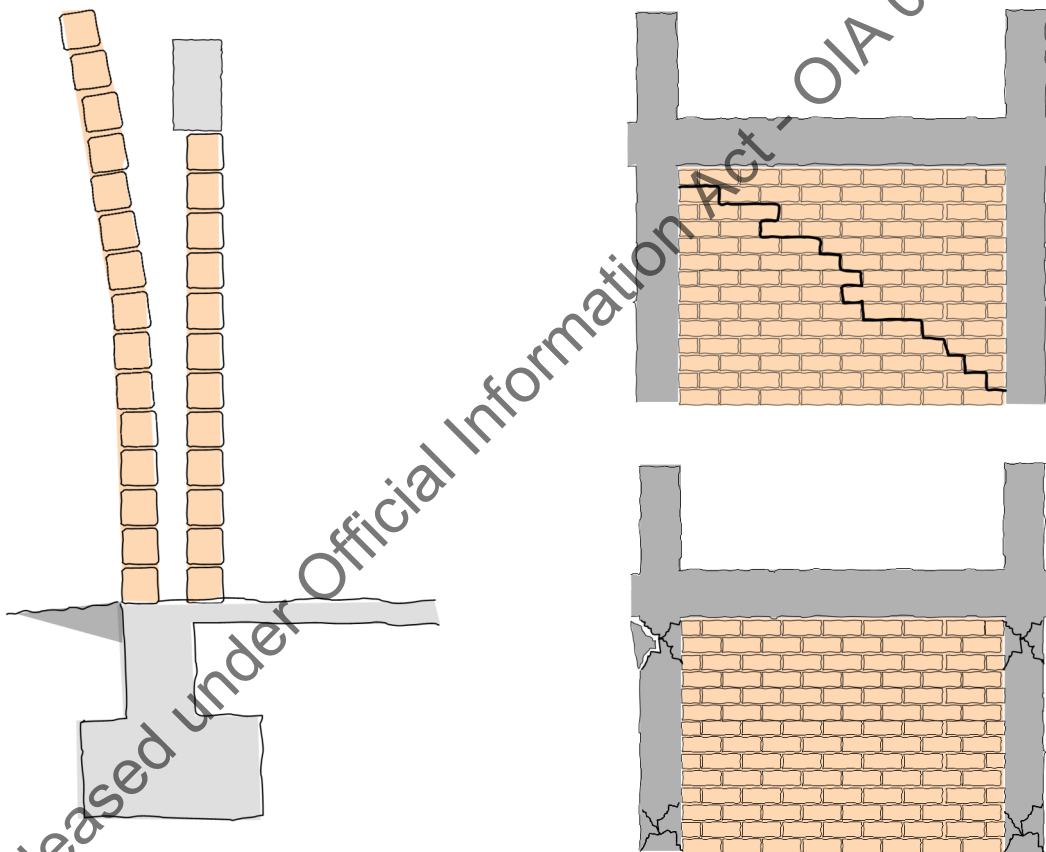
The critical structural weakness identified in the building is the unreinforced masonry (URM) walls failing out-of-plane. The key failure mechanisms evident in the structure are:

- Out-of-plane failure of the URM veneer 20%NBS (IL3)
- Shear failure of the concrete columns due to short-column effects 45%NBS (IL3)
- In-plane failure of the URM infill layer 50%NBS (IL3)
- Bare frame column flexural strength (URM removed) 80%NBS (IL3)

The exterior URM veneer is critical with a score of 20%NBS (IL3). There is no evidence of restraint to the top of these veneers, and the wall is thus required to cantilever from ground floor level.

**Figure 1: Clockwise - out-of-plane failure of the external veneer, direct tension failure of the URM infill, shear failure of the columns from short column effects**

The column shear failure is caused by the development of compression struts in the brick infill. These struts are eccentric to the frame intersection points, forming large shear demands in the columns or beams. As the smaller infills fail progressively in compression, the load is distributed to the larger walls which fail the columns. The column failure in shear is non-ductile and deemed a loss of gravity support to the roof structure.

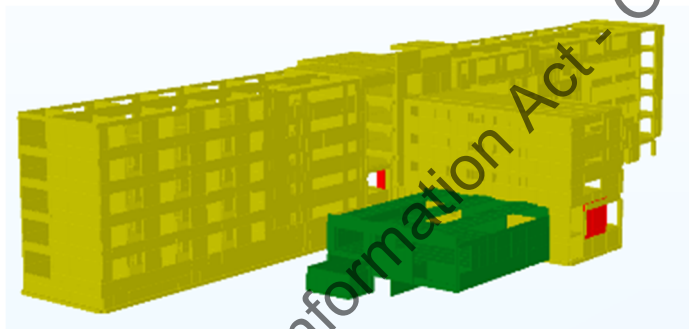
The score of the building is 25%NBS (IL3) governed by the performance of several isolated shear walls which have a disproportionate impact on the seismic rating to the building due to their importance to maintain support to the floors and lateral stability of the building.

Figure 2: 3D view of the Esme Green structural model with the elements < 34%NBS shown in red

- South Wing
  - Strengthen existing wall - Wall at ground floor level on Gridline 9 (in main lobby of building near the lifts) – retrofit with thickening to the wall
- East Wing
  - Removal or fixing back of unreinforced masonry veneer above the egress paths to the building
  - New wall - Additional wall at eastern elevation of the building

The figure below highlights the extent of strengthening required to achieve 35%NBS. The North Wing and Linen Store building do not require any strengthening to meeting this strengthening target.

We recommend that Option 1 (strengthening to 35%NBS) is pursued by Counties Manukau Health on the basis that it provides the best value and a 'sweet spot' between investment in strengthening and reduction in the seismic risk. It is our understanding that the Esme Green building is not part of CMH's long-term plan for the site and hence any major investment in the building is non-preferred.
