Facilities : Remediation works
Proactive Release: 19 July 2019

Project:
SCOTT BUILDING EXTERNAL REFURBISHMENT MIDDLEMORE HOSPITAL
For: COUNTIES MANUKAU HEALTH
Drawing Title:
PROPOSED EAST ELEVATION

Test report: 1463-51

AAMA 501.2 and AAMA 502 Field Testing of three existing windows at Middlemore Hospital's Scott Building Level 4

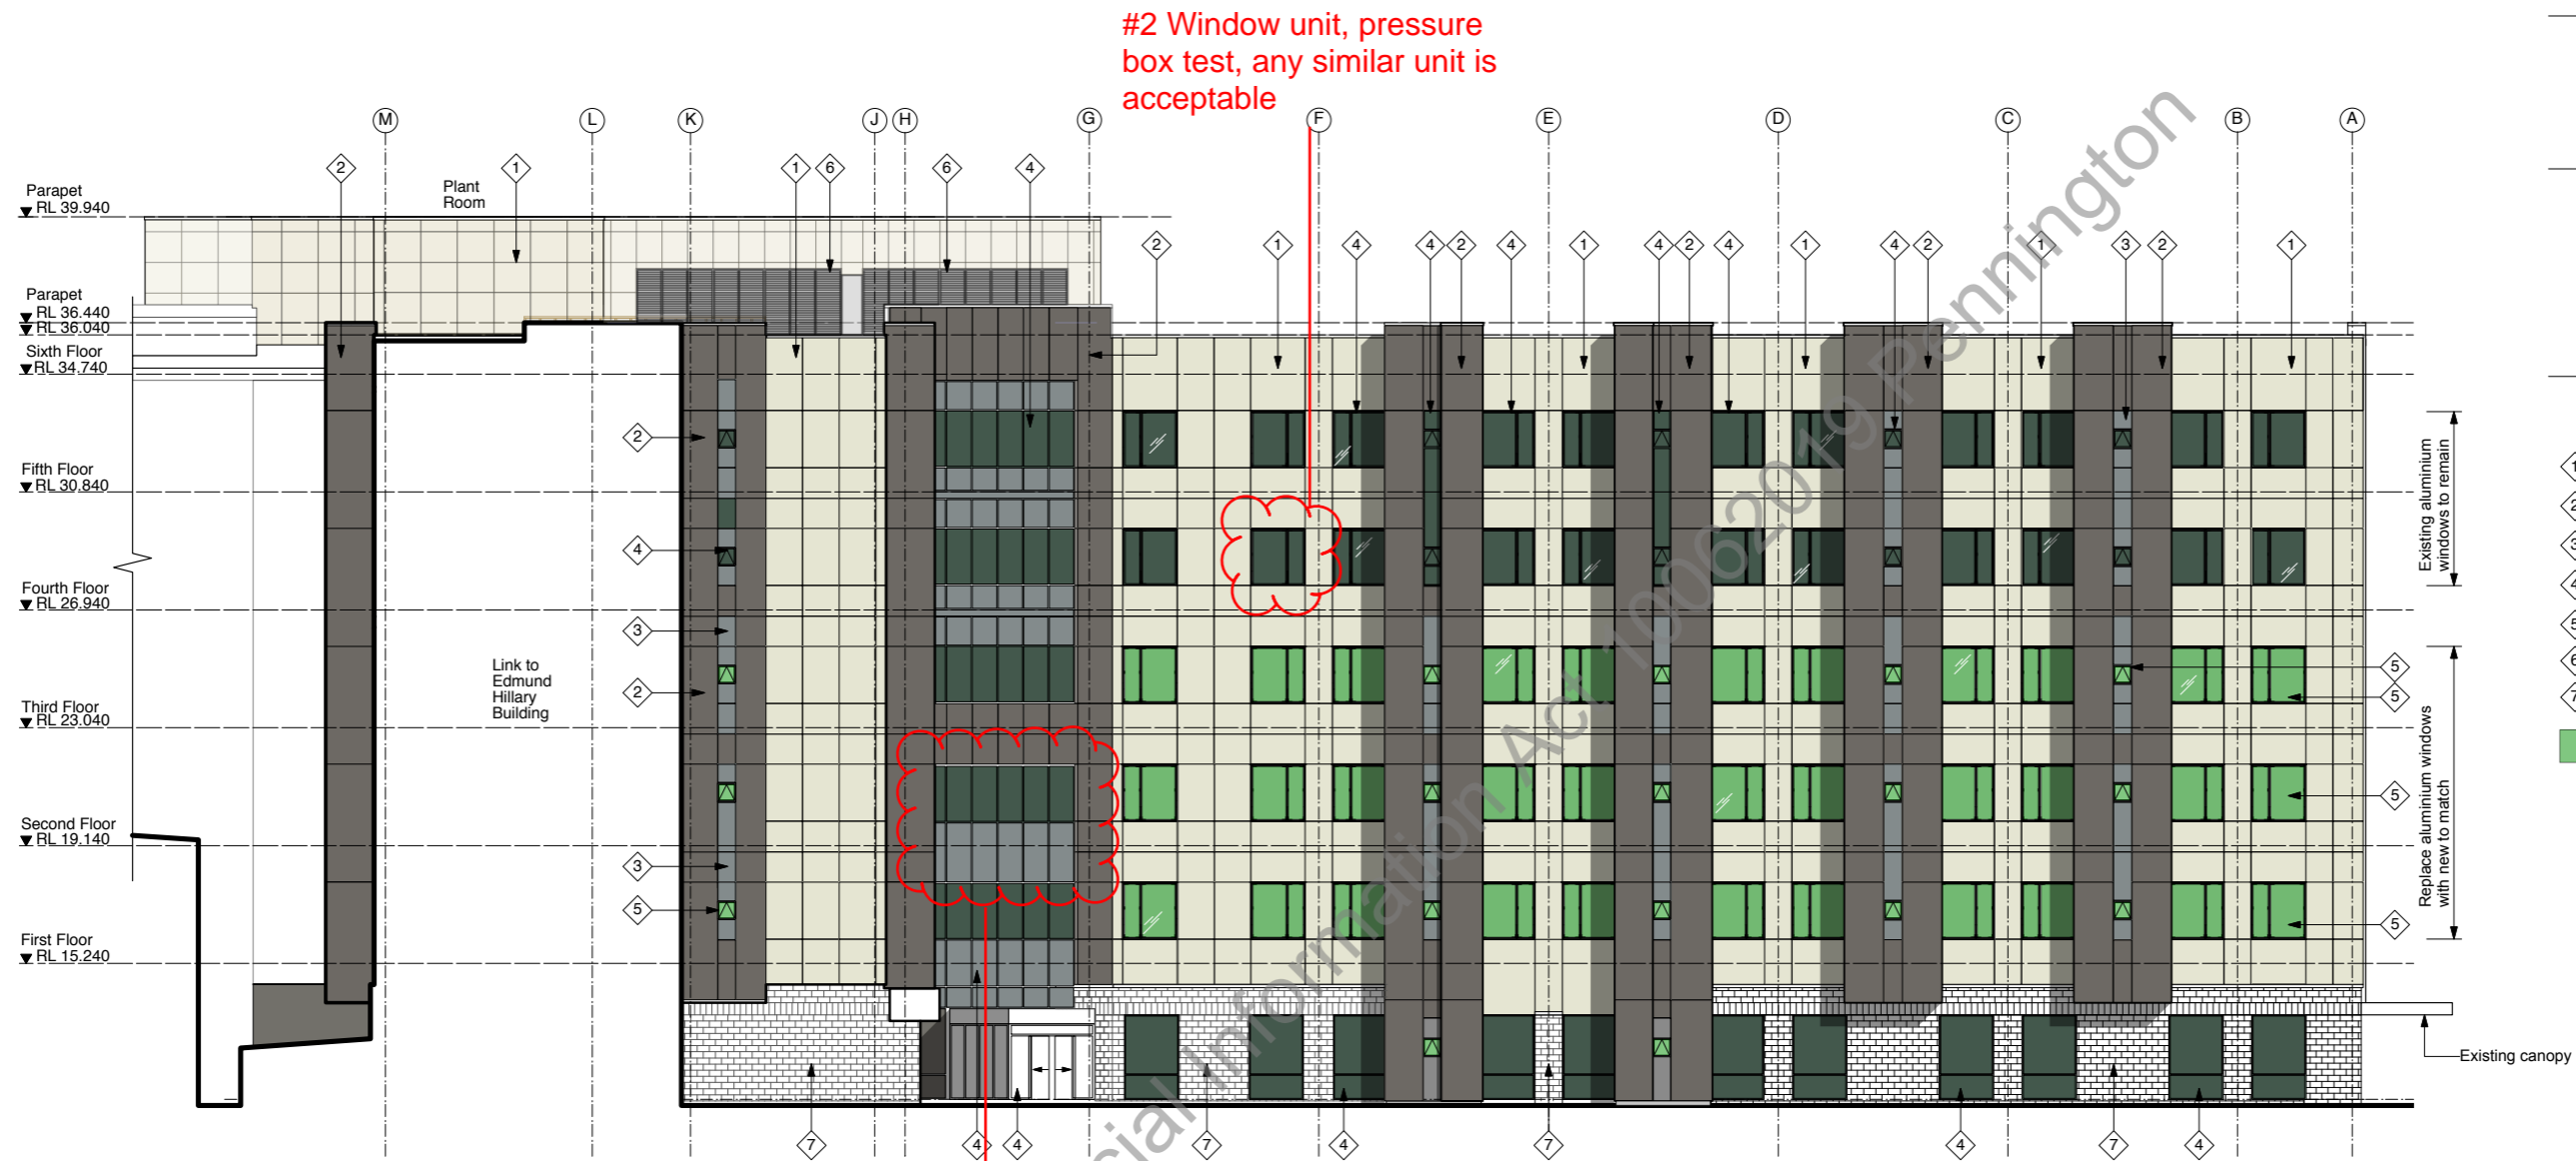
1 PROPOSED EAST ELEVATION
1:250 @ A3

#1 Main entrance curtain wall, site water hose test, any similar curtain wall location is acceptable

#2 Window unit, pressure box test, any similar unit is acceptable

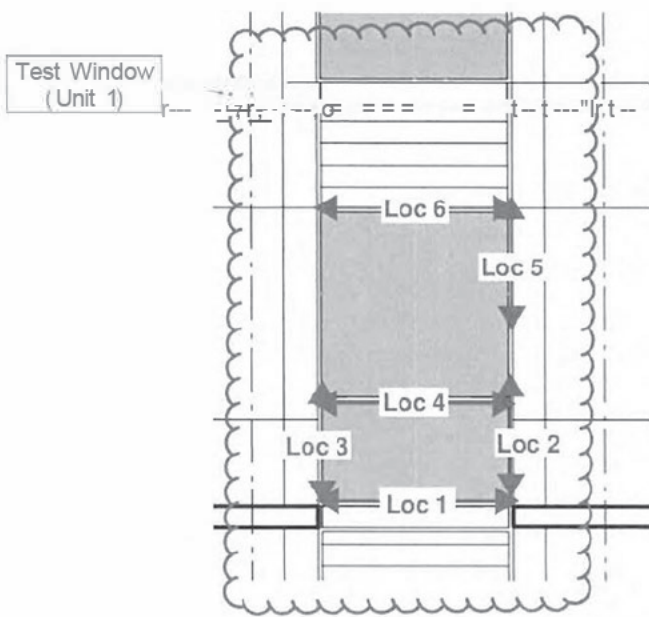
There was uncontrolled water penetration at test location 6 - the vision-spandrel horizontal member. The water appeared to enter the building at the junction between the louvre plenum and the window transom. All other locations tested showed no visible water penetration.

Loe	Time	Notes
1	12.03-12.08	OK
2	12.08-12.13	OK
3	12.26-12.31	OK
4	12.31-12.36	OK
5	12.39-12.44	OK
6	12.45-12.47	Water penetration visible at both ends.

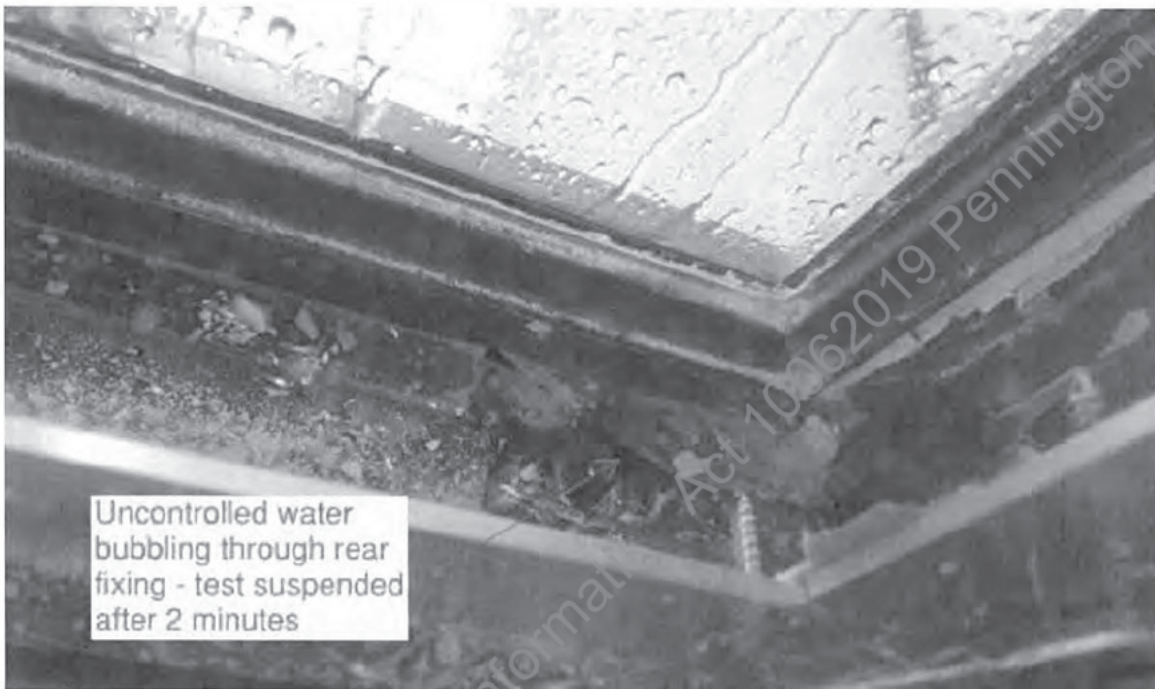
There was uncontrolled water penetration through the right-hand-side rear sill tray fixing after 2 minutes of testing at 200 Pa static pressure. Testing was suspended after approximately 3 minutes of static pressure to avoid water damage to the surrounding structure with no other leak locations observed in this time.

The test was suspended after 2 minutes of pressure differential as uncontrolled water was entering the building through the right-hand-side rear sill fixing when viewed from inside.

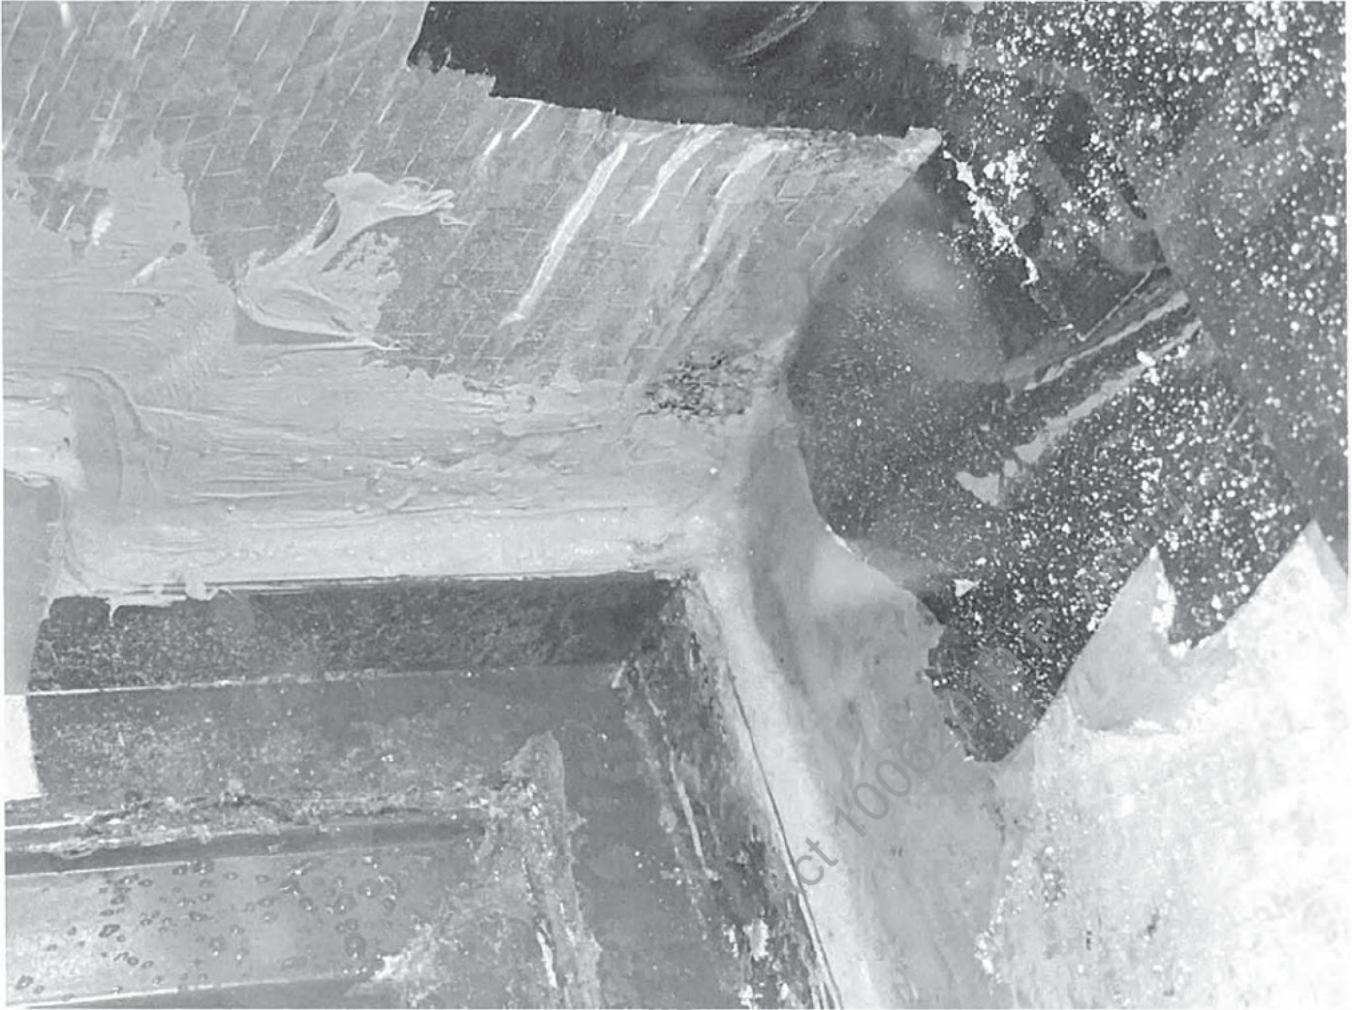
There was uncontrolled water penetration through the right-hand-side rear mitre joint between the sill and the jamb of the awning sash perimeter frame. Air leakage was also noticed at the same location on the left-hand-side under 300 Pa static water pressure.

After 8-mins 30-secs, the pressure was reduced to 200 Pa with water still penetrating at the same location. The test was suspended after 10mins.

Again, the window was soaked for 5 minutes prior to applying the specified 300 Pa pressure differential. Immediately, air leakage was observed via localised dust through the mitre joints of the awning sash perimeter frame. Uncontrolled water slowly entered through the RHS lower mitre joint. After 8 minutes, the pressure was adjusted to a 200 Pa differential and water and air leakage was still observed before testing was suspended after 10 minutes.

Figure 8 Uncontrolled water penetration through rear mitre joint. Evidence of oxidation damage to aluminium framing at mitre joints on both sides.

- However, the testing conducted in April 2019 did identify faults, and the seals will need to be renewed as a part of the remediation programme. Options to remedy this issue are being investigated. Based on the results, the 25-year major scheduled maintenance will be advanced, and the windows independently retested.
