#### Official Information Act (1982) Request

The three buildings that underwent DSA following unsatisfactory ISA results, and which we are now releasing as attached documents, are Franklin Memorial Hospital, Pukekohe Plant Room and Esme Green.

Beca has been engaged to complete intrusive investigations at the Franklin Memorial Hospital site at Waiuku, Auckland. The investigation findings will inform the next steps of the seismic assessment and strengthening process. This letter summarises our findings and provides options and recommendations for Counties Manukau Health (CMH) to consider.

Beca has been engaged to complete intrusive investigations at Building 38 located on the Middlemore Hospital campus, in Otahuhu, Auckland. The investigation findings will inform the next steps of the seismic assessment and strengthening process. This letter is a factual summary of our findings and provides options and recommendations for Counties Manukau Health (CMH) to consider.

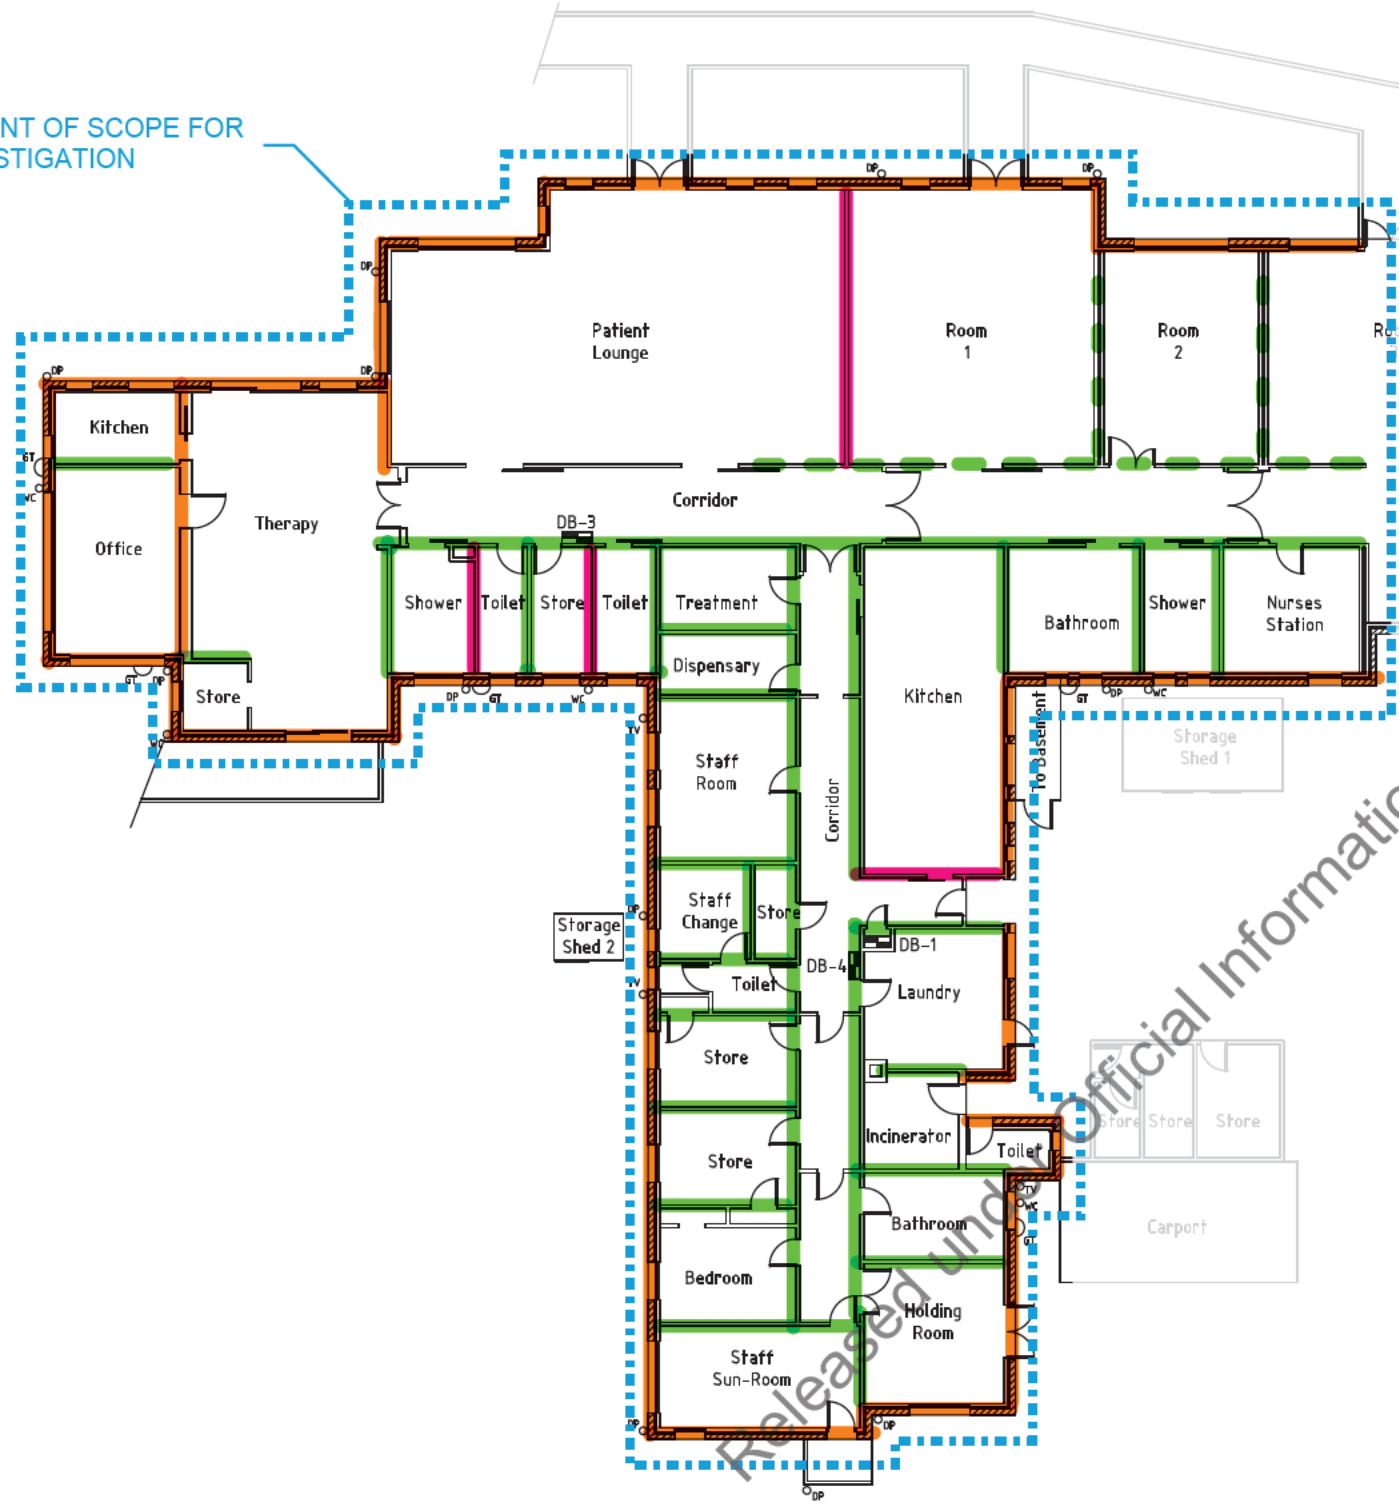
EXTENT OF SCOPE FOR INVESTIGATION

- To determine whether the brick masonry walls observed in the Franklin Memorial Hospital Building are:
- Load-bearing or veneer / partition walls
  - Cavity, single leaf, or solid brick construction (may vary up height of building)
  - Have ties in the cavity, or veneers are tied back, and the condition of these ties
  - Have suitable connection details to restraints at ceiling/roof, ground floor, and foundation locations

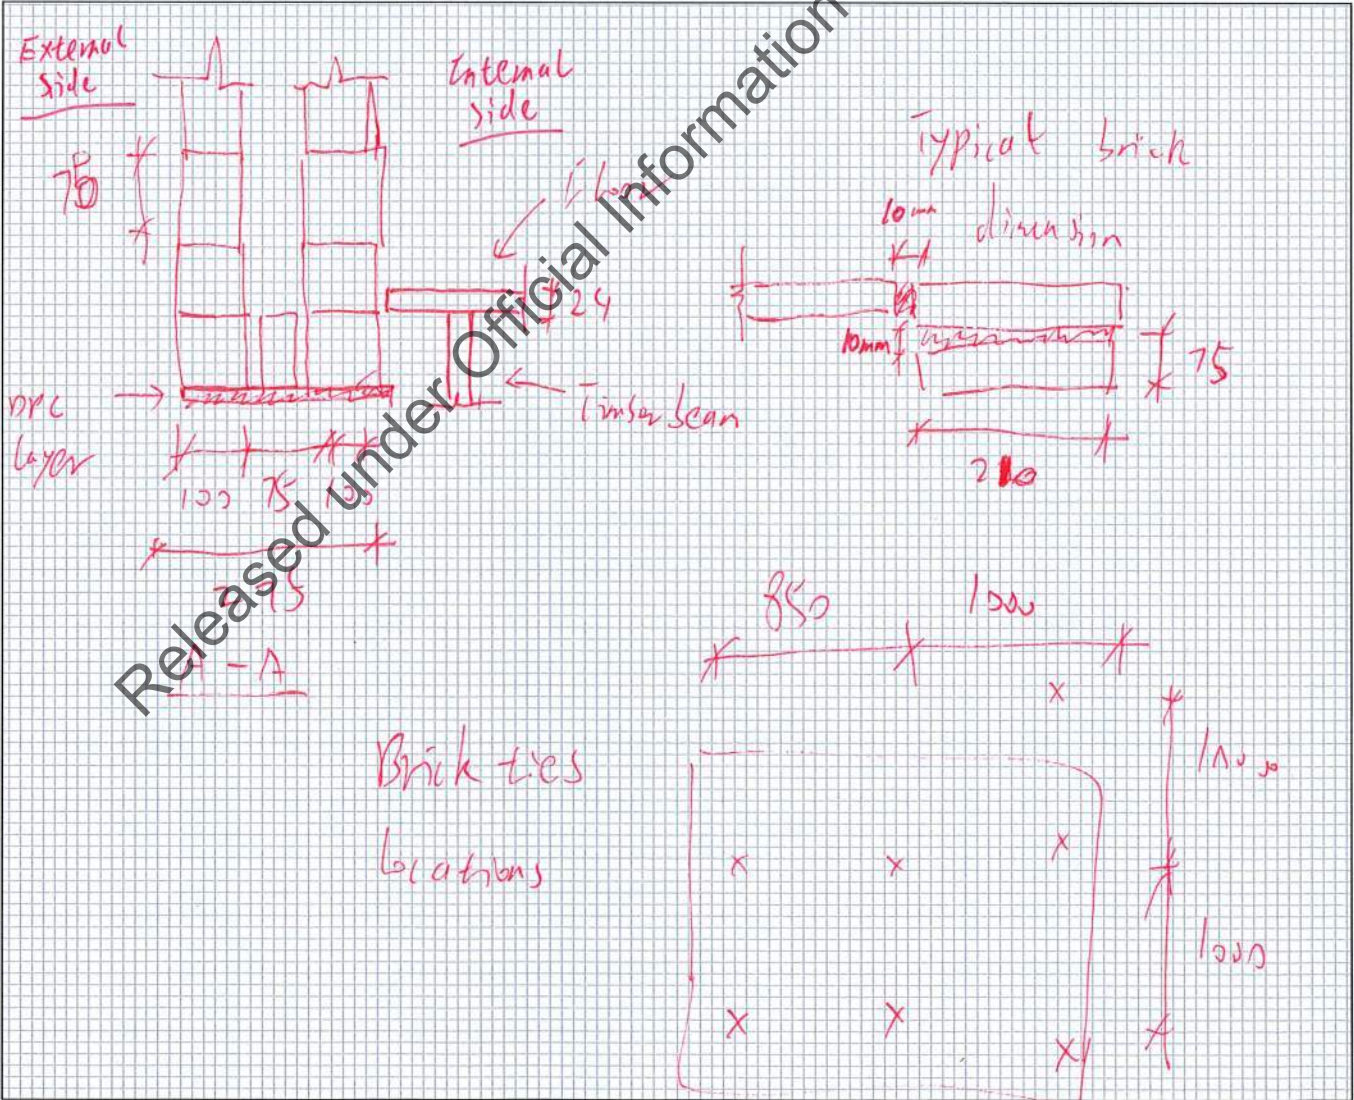
Description/Comments: Exterior wall on southern side of building. removed the ventilation net to observe cavity construction. Bricks with minor cracks.

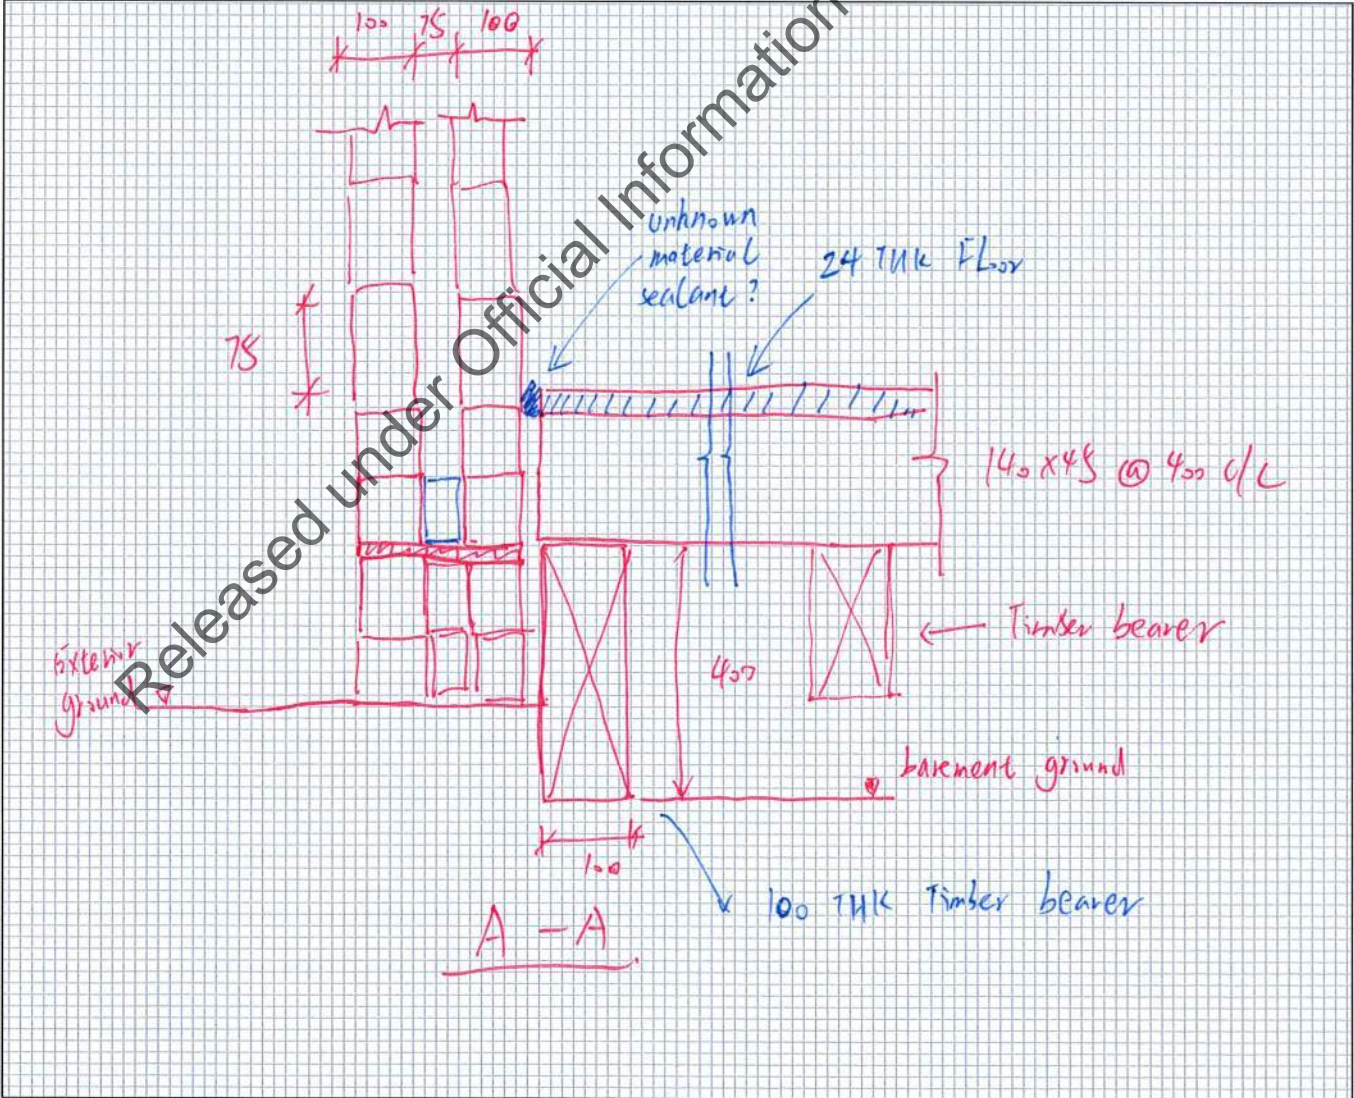
Wall in good condition with minor cracks.  
- Brick tie spacing similar to wall 1.

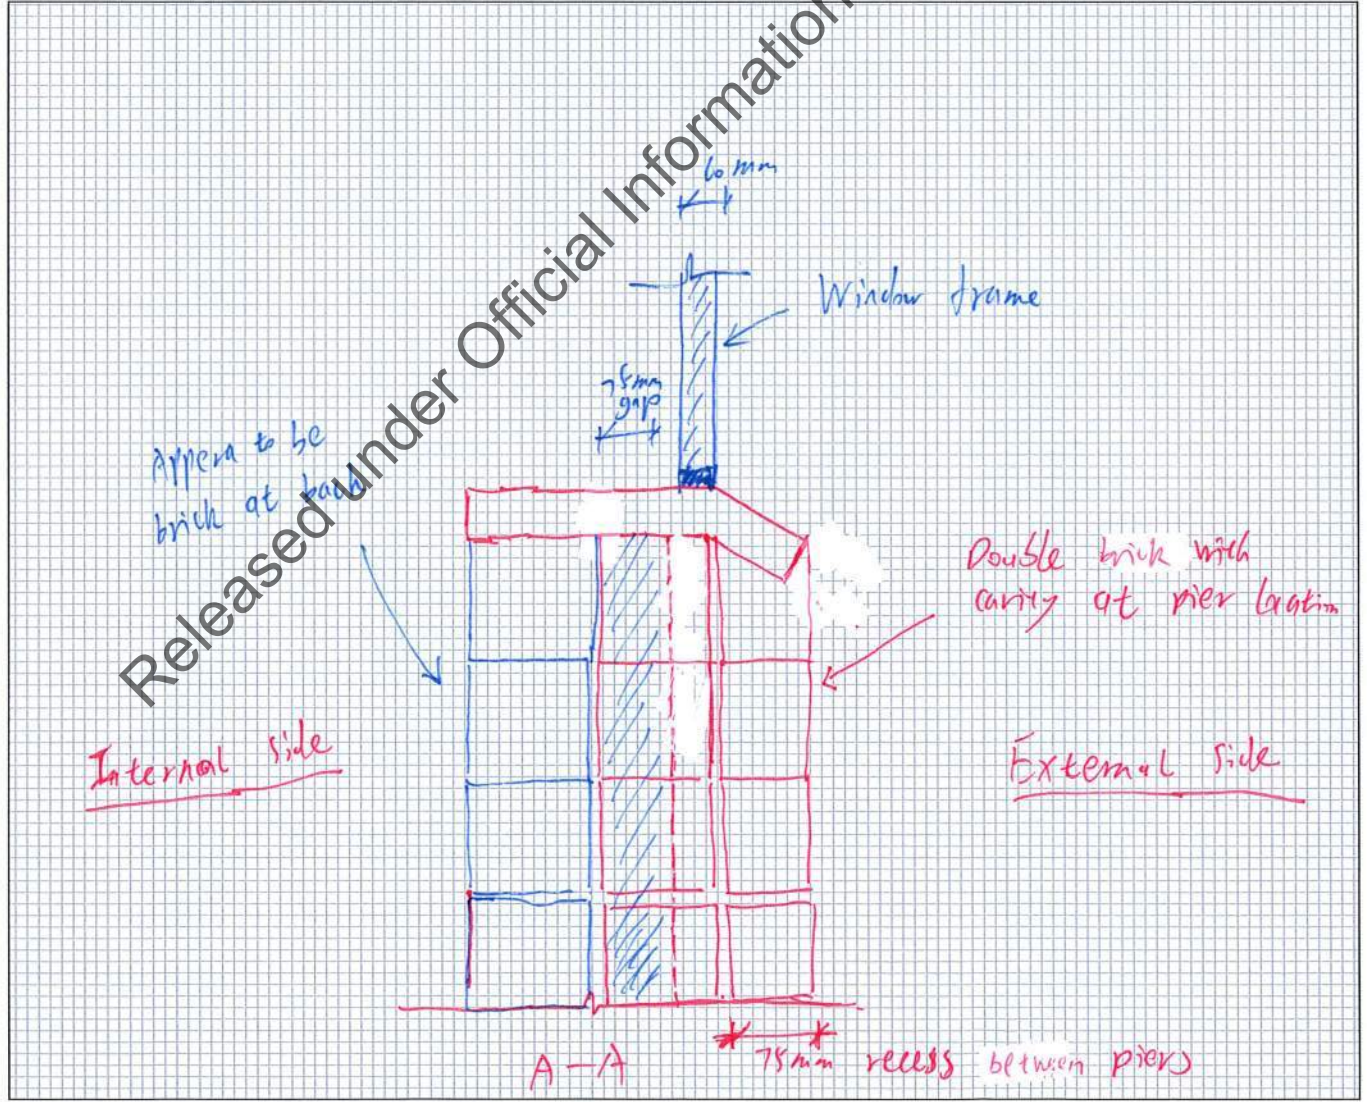
Description/Comments: *- New Mortar repair in late stage*  
*- wall recess 75mm from exterior*  
*- No brick to found on this wall*  
*- Minor cracks on bricks*

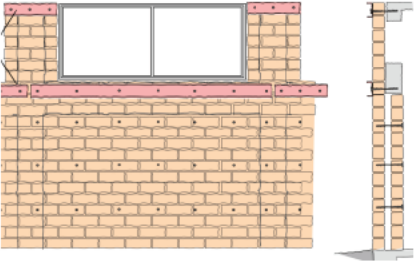
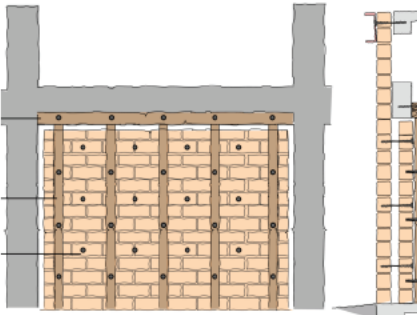
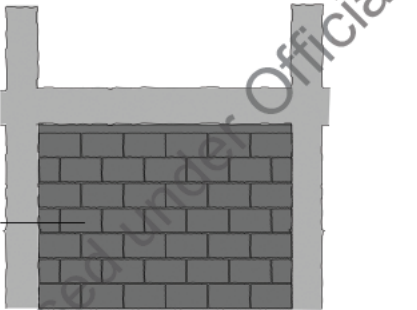
The options can be summarised holistically in the table below:

Beca recommends that Option 2 is adopted as the best balance of improved seismic performance with minimised disruption.

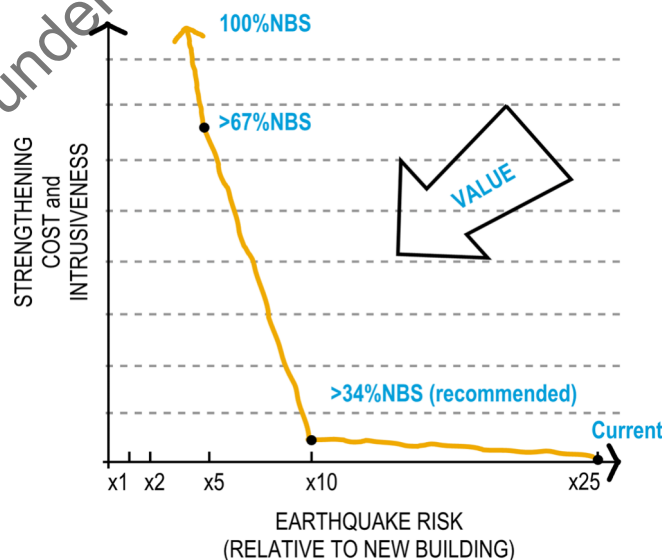
Figure 1: Graph of the relative earthquake risk and strengthening costs to improve

The graph below shows the relationship between the effort to strengthen (cost and intrusiveness on occupants) and the earthquake risk for the Esme Green building. It can be seen that the largest improvement in the earthquake risk is achieved by pushing the building from where it currently sits, to >34%NBS.

As the target level is increased, the strengthening costs and intrusiveness increase disproportionately for the Esme Green Building. This is due to the age and construction of the building. While there are few elements that are < 34%NBS, there are numerous members that sit in the Earthquake Risk range of 34 – 67%NBS and strengthening schemes would need to fundamentally change the structural system of the building.

## Strengthening to 35%NBS (Recommended)
