Facilities : Remediation works
Proactive Release: 19 July 2019

Project:
SCOTT BUILDING EXTERNAL REFURBISHMENT MIDDLEMORE HOSPITAL
For: COUNTIES MANUKAU HEALTH
Drawing Title:
PROPOSED EAST ELEVATION

Test report: 1463-51

AAMA 501.2 and AAMA 502 Field Testing of three existing windows at Middlemore Hospital's Scott Building Level 4

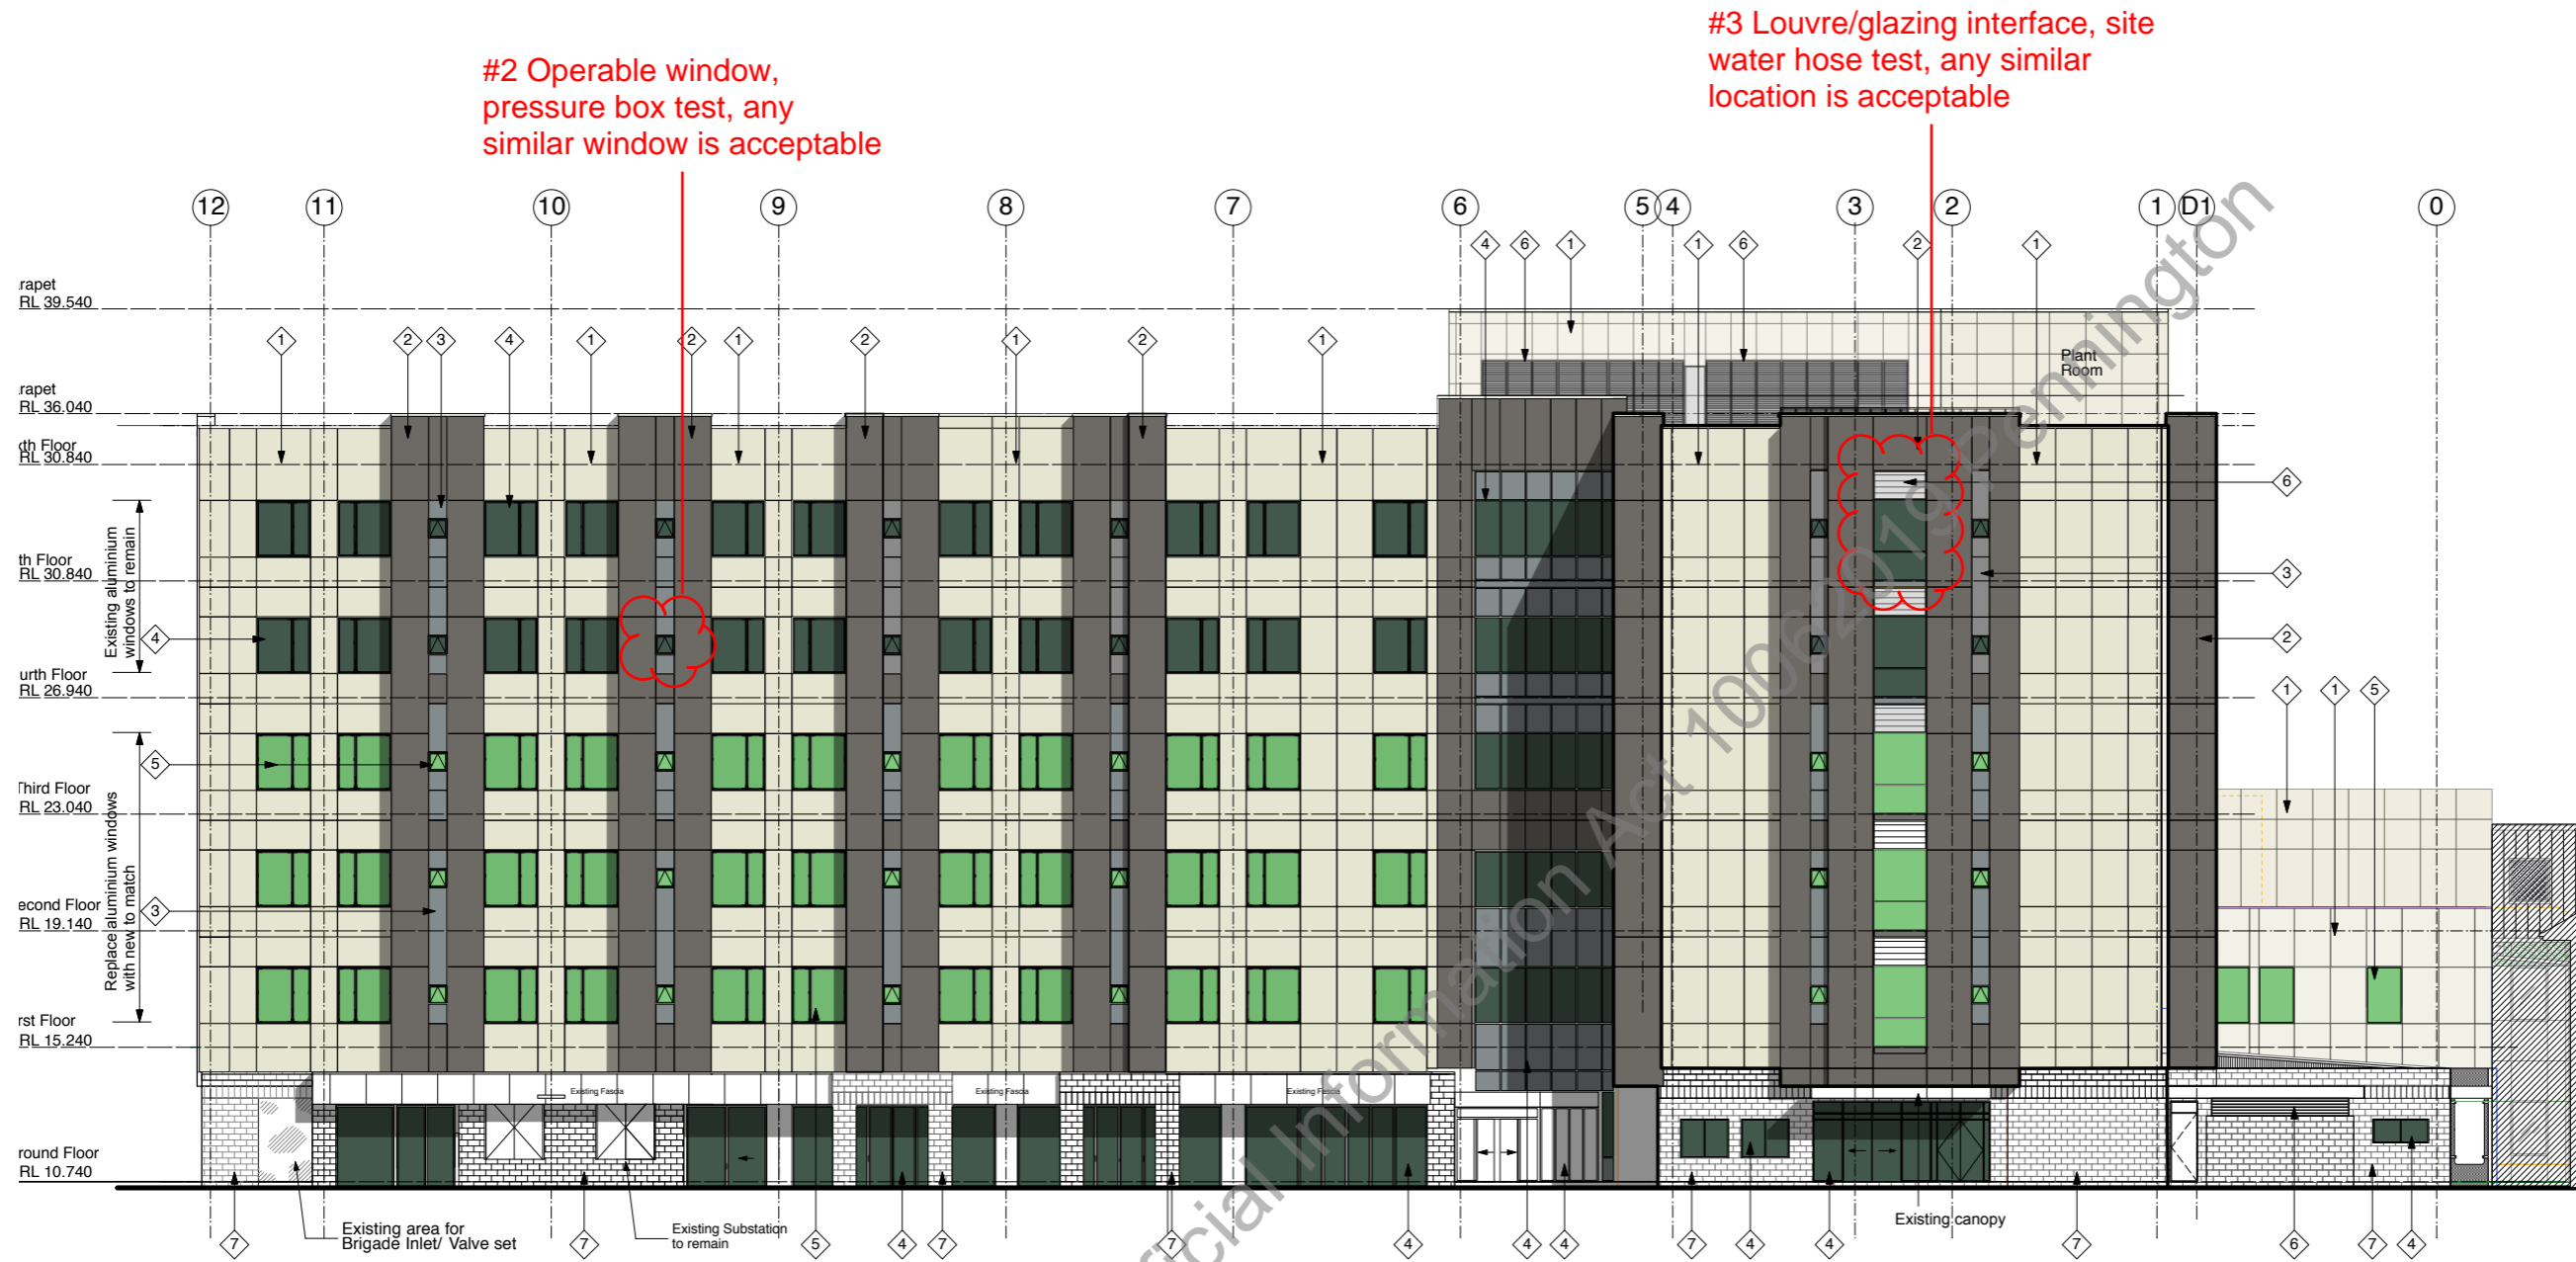
Job No: Drawing No: Revision:
3.1033 RC-210 A

Note: Test locations suggestions only, will depend on availability of safe access.

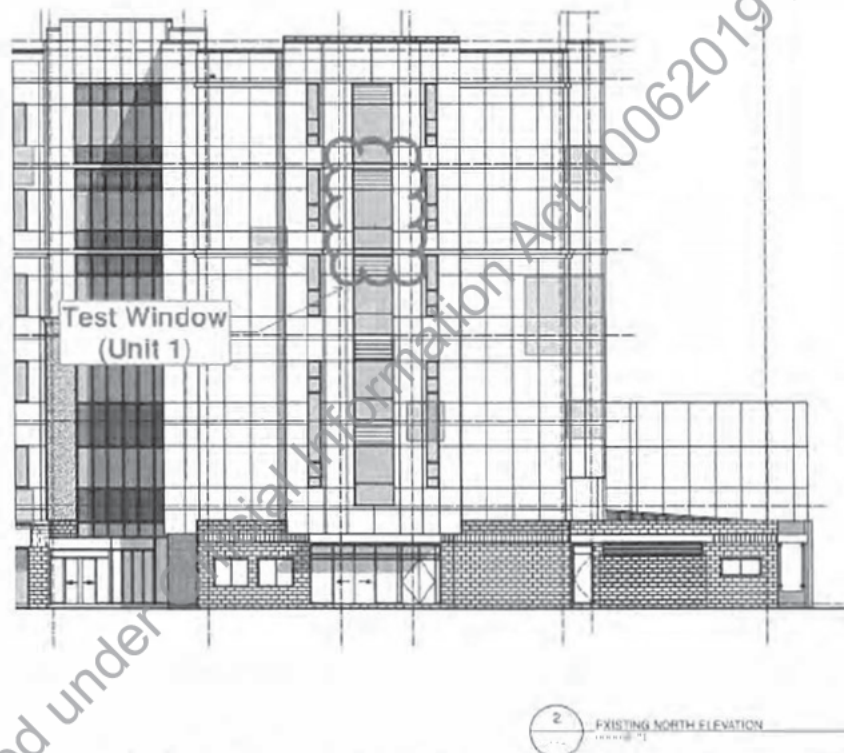
2.0 TEST SETUP and RESULTS**Unit 1: Corridor Strip curtainwall panel with louvre spandrel panel**

Loe	Time	Notes
1	12.03-12.08	OK
2	12.08-12.13	OK
3	12.26-12.31	OK
4	12.31-12.36	OK
5	12.39-12.44	OK
6	12.45-12.47	Water penetration visible at both ends.

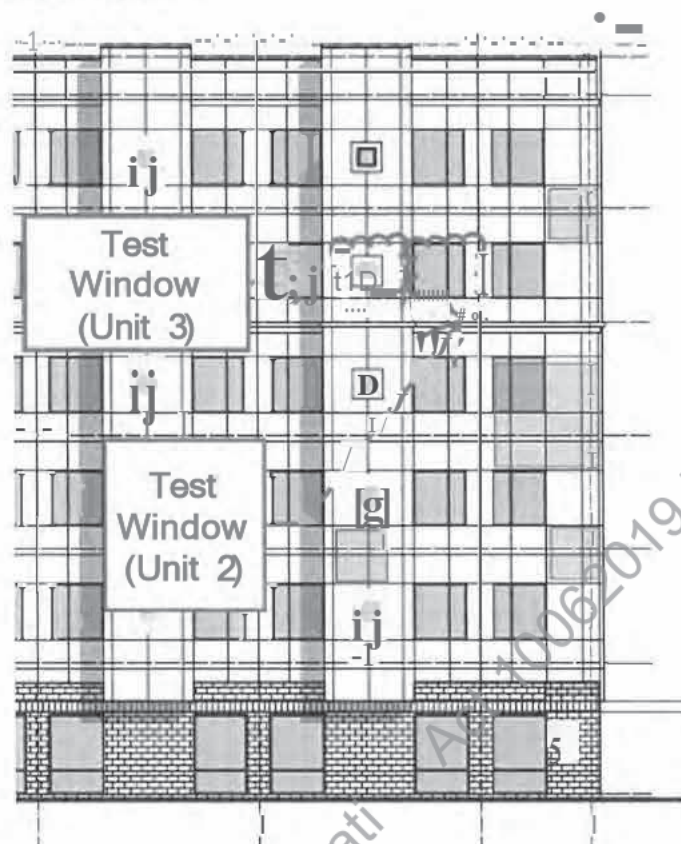
Unit 2: Bed-room fixed window

Again, the window was soaked for 5 minutes prior to applying the specified 300 Pa pressure differential. Immediately, air leakage was observed via localised dust through the mitre joints of the awning sash perimeter frame. Uncontrolled water slowly entered through the RHS lower mitre joint. After 8 minutes, the pressure was adjusted to a 200 Pa differential and water and air leakage was still observed before testing was suspended after 10 minutes.
